**BAR HARBOR PUBLIC SAFETY BUILDING
FEASIBILITY STUDY**

October 8, 2012

ARCHITECT
Design Group Collaborative
Ellsworth, Maine

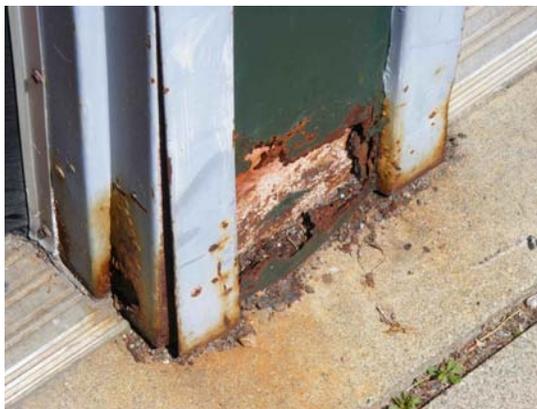
Minor areas of repair were found at the entry canopy roof flashing and the public bathroom door steel frames are rusting.

Door Frame outside Bathroom entrance.

-Moisture issues are apparent in the interiors that indicate lack of ventilation. Rusting and damage at the bottom of door steel frames should be repaired.

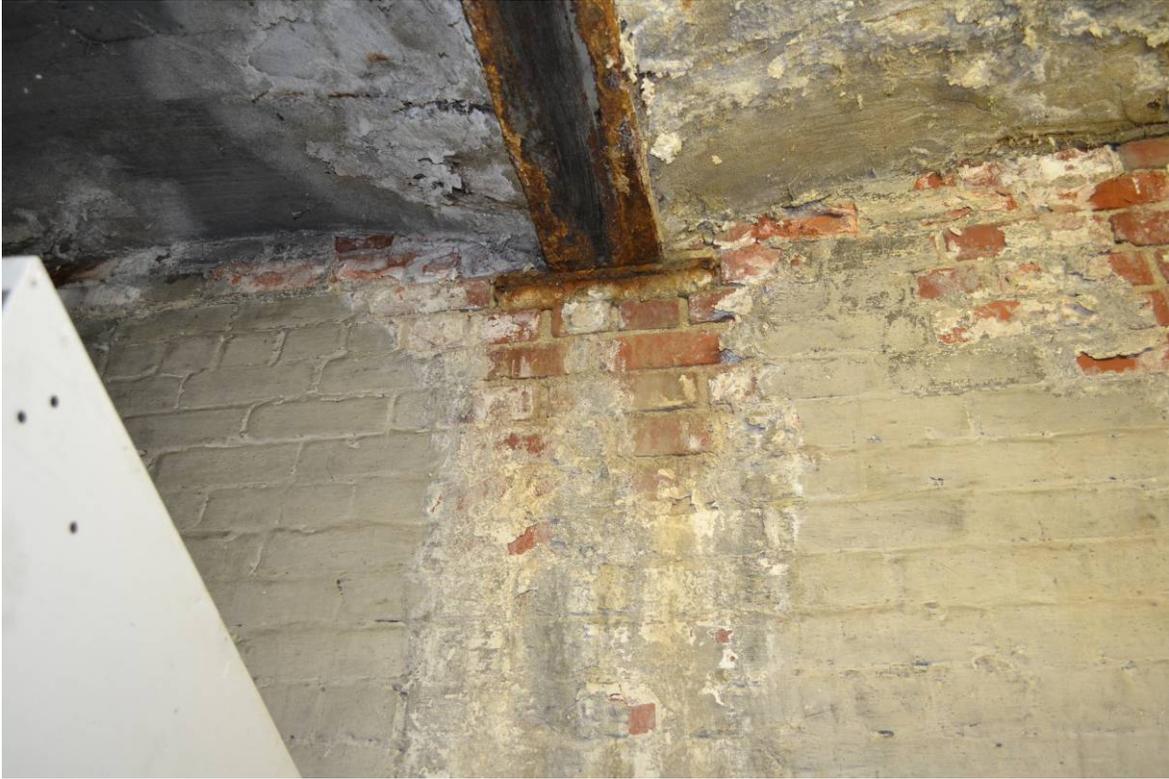
The structure generally appears to be in fair to good condition considering its vintage and use. Some 1st floor steel support members show evidence of deterioration (see Photos 1 & 2). The damage that is visible appears to be related to water intrusion through the first floor slab system. It is likely that additional damage to the structure exists that is not visible. The efflorescence visible on the masonry also indicates water intrusion and some damage to the concrete deck is likely hidden within the ceiling system. No indications of major structural deflection were noted during the visit and preliminary calculations of the floor system indicate that the structure has capacity to serve the intended purpose. Localized structural damage that is hidden may reduce that capacity. The condition of the hidden structure should be more thoroughly investigated if long term re-use of the structure for vehicular loading is considered. This additional investigation would likely entail some demolition so that hidden connections and members could be uncovered. The use of an elevated floor for vehicular loading and the associated water intrusion into the structure will likely continue to advance any existing deterioration. It is likely that some major renovation to the floor structure would be required if the Town should decide continue the current use for the long term.

Photo 1: 1st floor steel beam deterioration and water damage

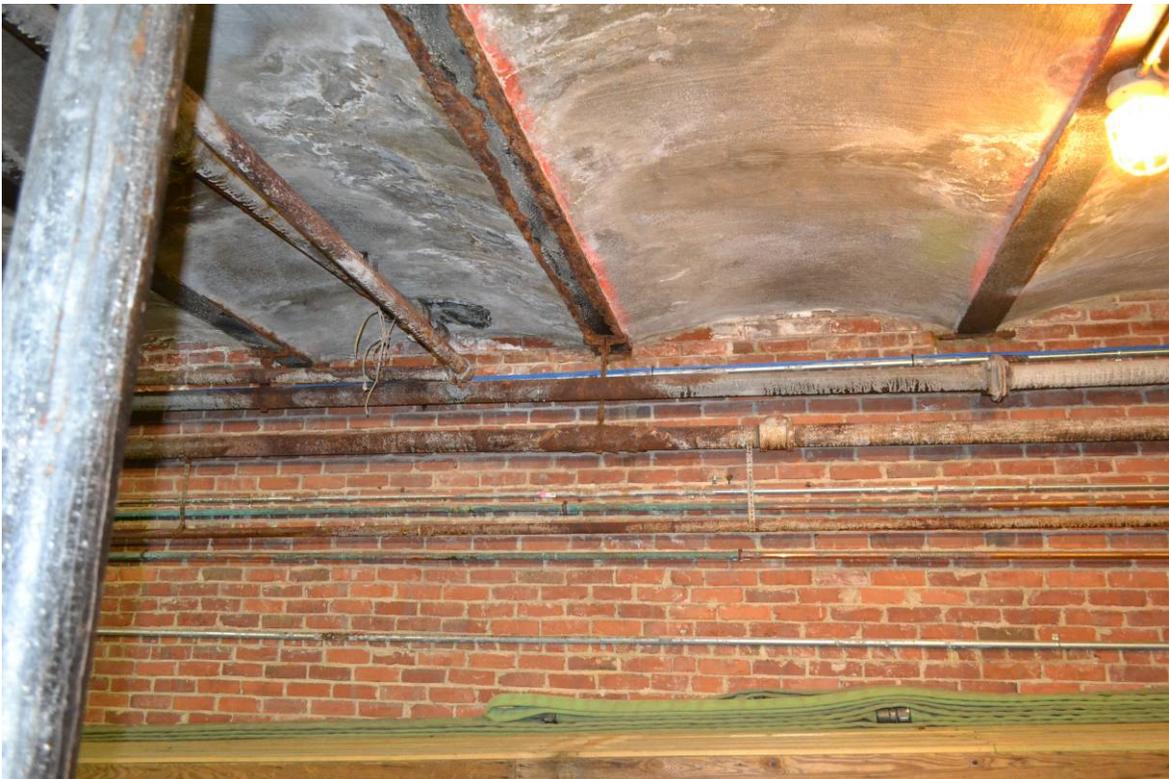
Photo 2: 1st floor steel beam deterioration and water damage

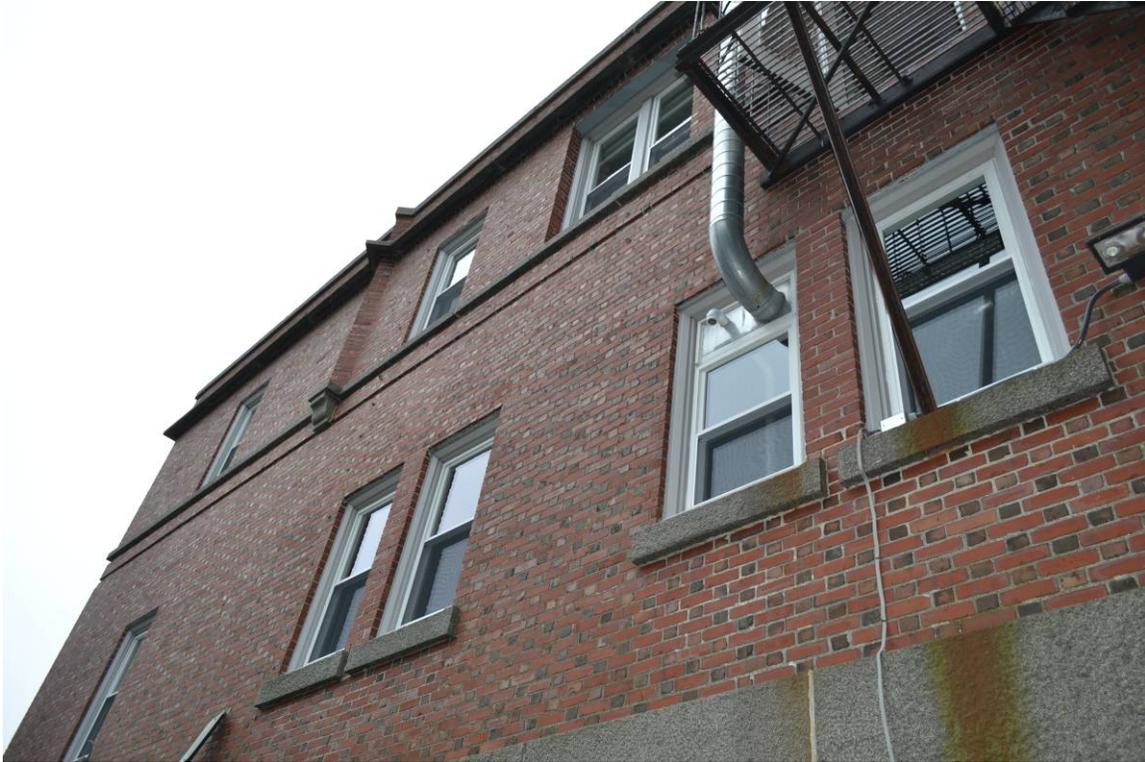
The masonry wall system for the building appears to be in good condition for a building of this age. It appears that the building has been well maintained and the masonry cared for with sealants and periodic mortar touch-up. (See Photo 3) Some minor masonry cracking is evident in some areas such as at the garage doors on the south side of the building where efflorescence indicates that water

Photo 3: North side of building. Brick in generally good condition

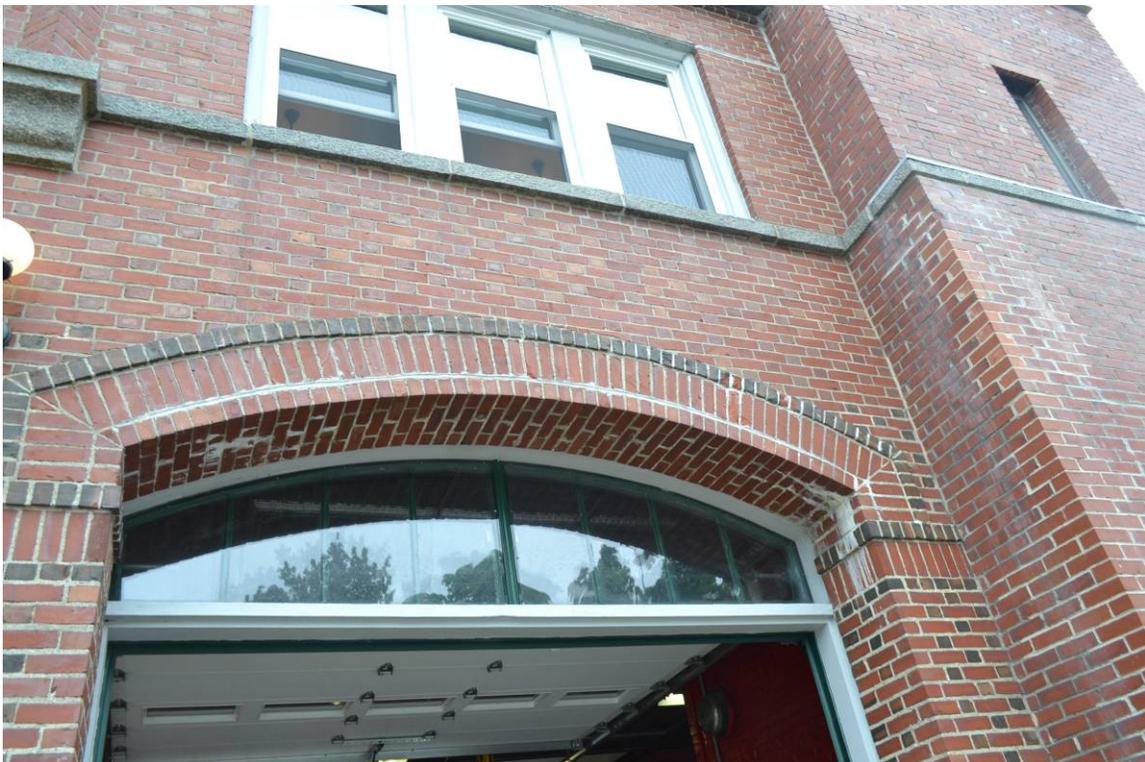
intrusion is occurring. (See photo 4 & 5). Some areas have been patched and that patching may have used mortar inconsistent with the original brick and mortar, thus leading to some future issues. It was also noted that some window lintels show evidence of rust and local mortar damage due to this steel deterioration. (See photo 6) The concrete foundation appears to be in generally good condition with only minor cracking in isolated locations (See photo 7). The crack in photo 7 appears to be relatively recent and may be associated with work that occurred in connection with the installation of the generator and battery system in this area.

Photo 4: Garage door at South side of building. Efflorescence visible on brick indicating water intrusion

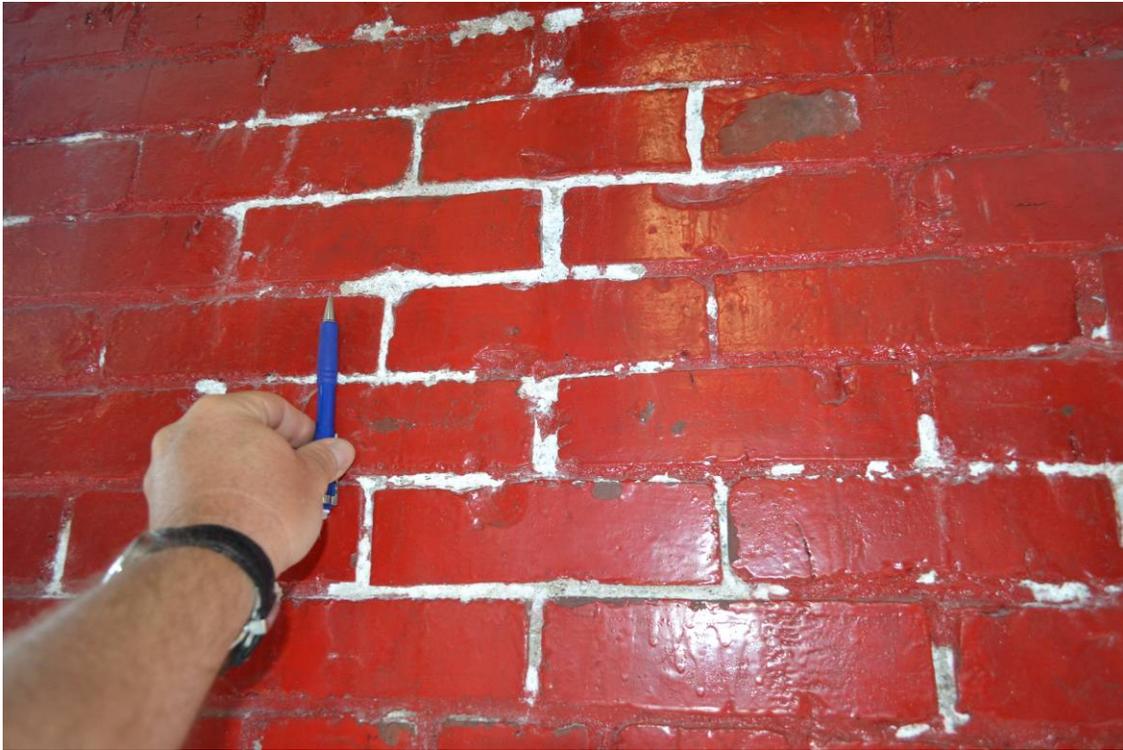
Photo 5: Efflorescence on inside of south wall column near overhead door due to water intrusion into wall.

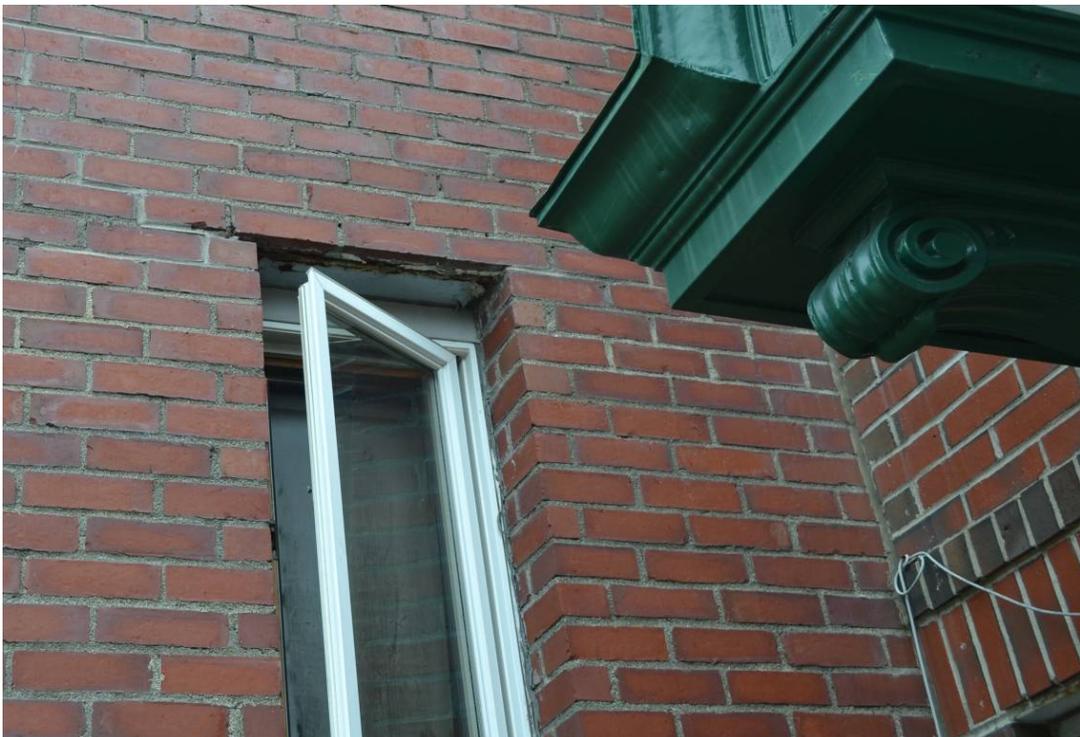
Photo 6: Lintel damage and associated masonry damage

-Steel lintels and door frames should be cleaned and repaired and painted.

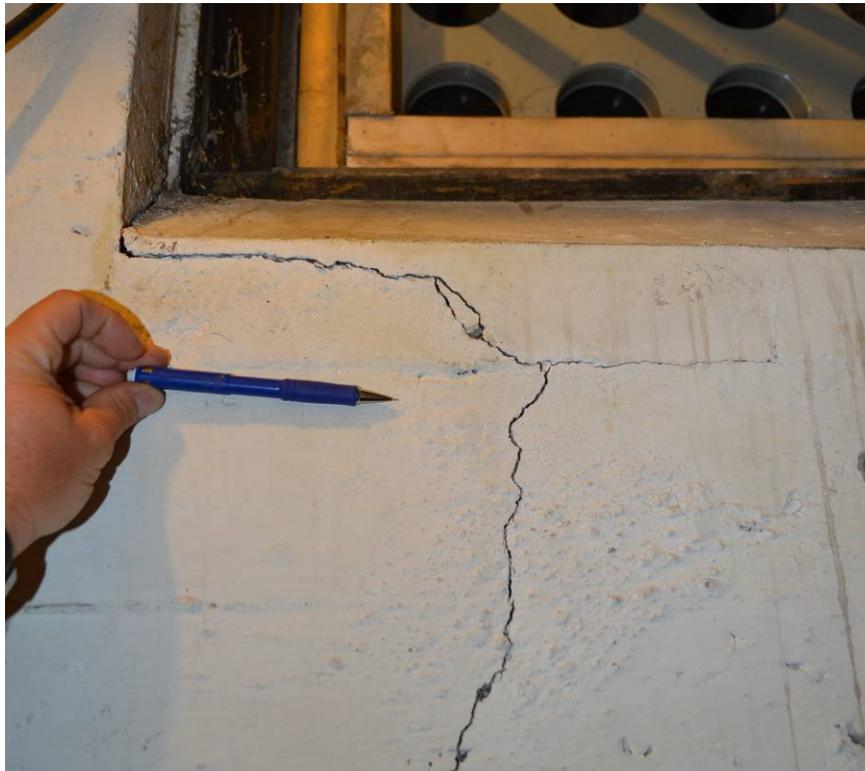
Photo 7: Crack in concrete foundation on west wall where conduits enter

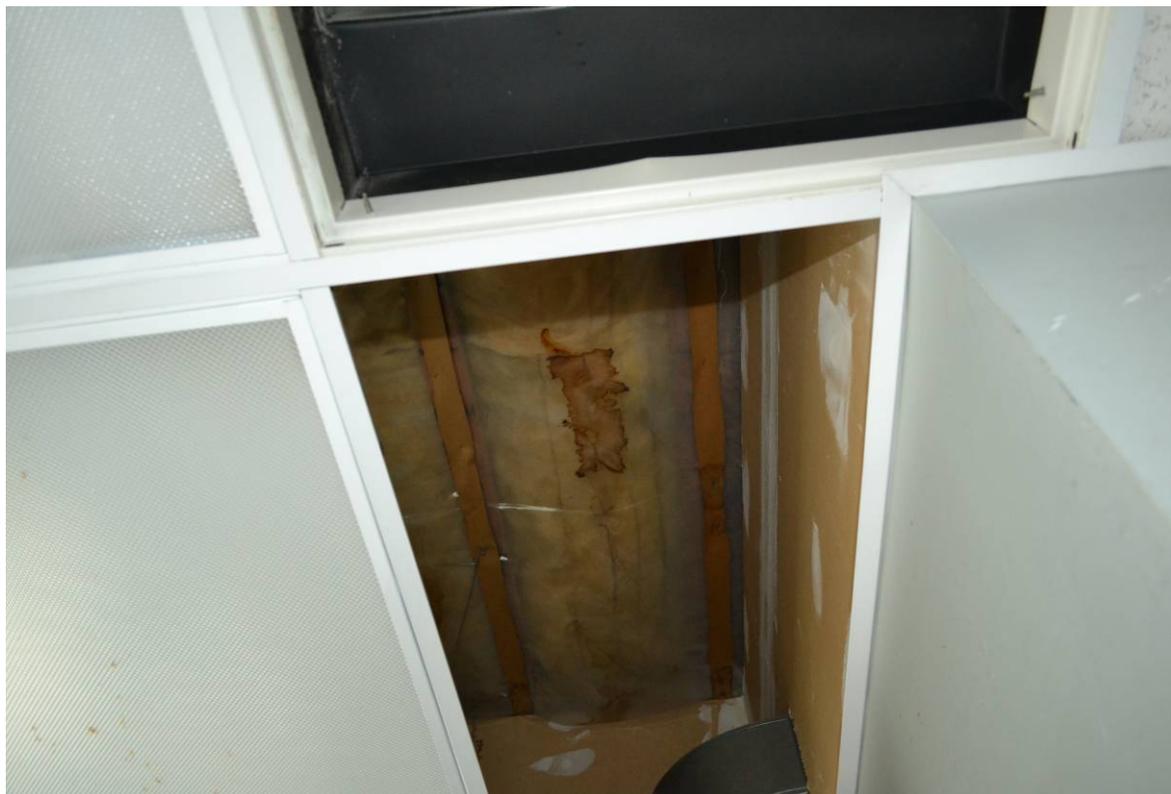
The addition is in generally good condition. The structural system appears adequate. Some water intrusion from the roof is evident on the east side. (See Photo 8) This, or other water intrusion in the past may have contributed to some hidden structural damage, but no major structural deflections or damage was observed during the site visit.

Photo 8: Water leaking from roof at east side of Police addition
