Ferry Terminal Inspection and Assessment FINAL REPORT

Bar Harbor, Maine

February 8, 2021
Project 2004148

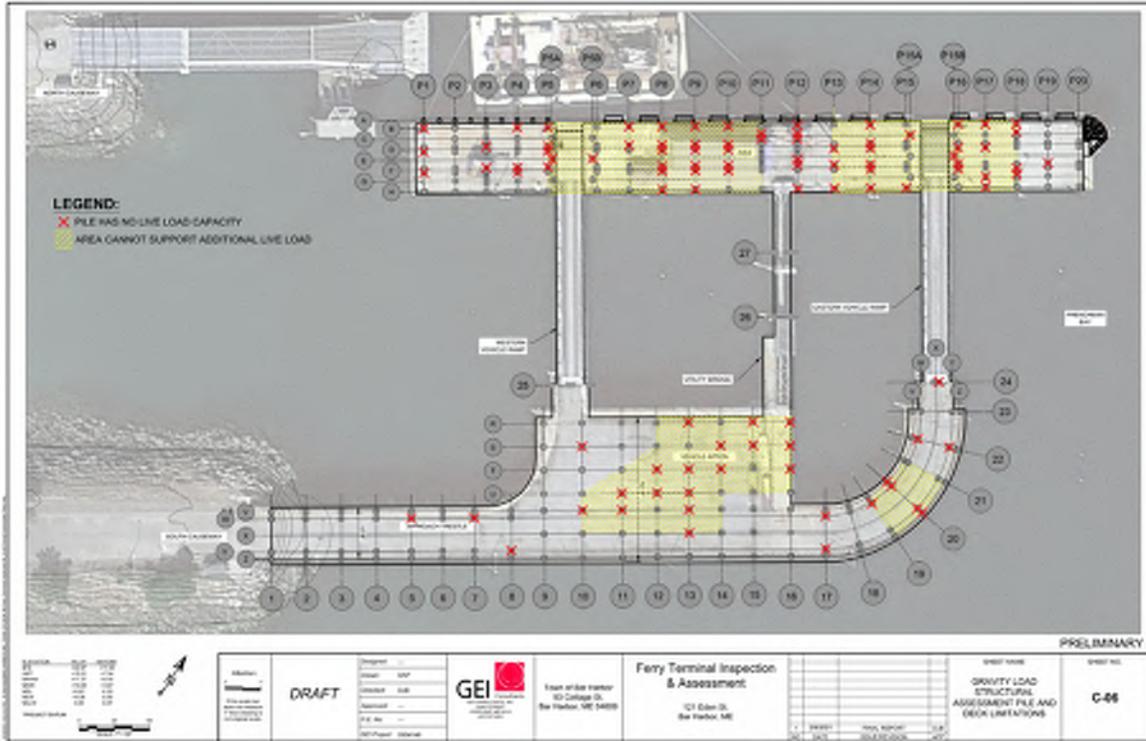
Fig. 6 – Locations of LC-Piles and No Remaining Live Load Capacity on Pier Deck

provided in Appendix B. The ‘no remaining live load capacity’ condition dictates the capacity for approximately 40% of the South Pier deck area.

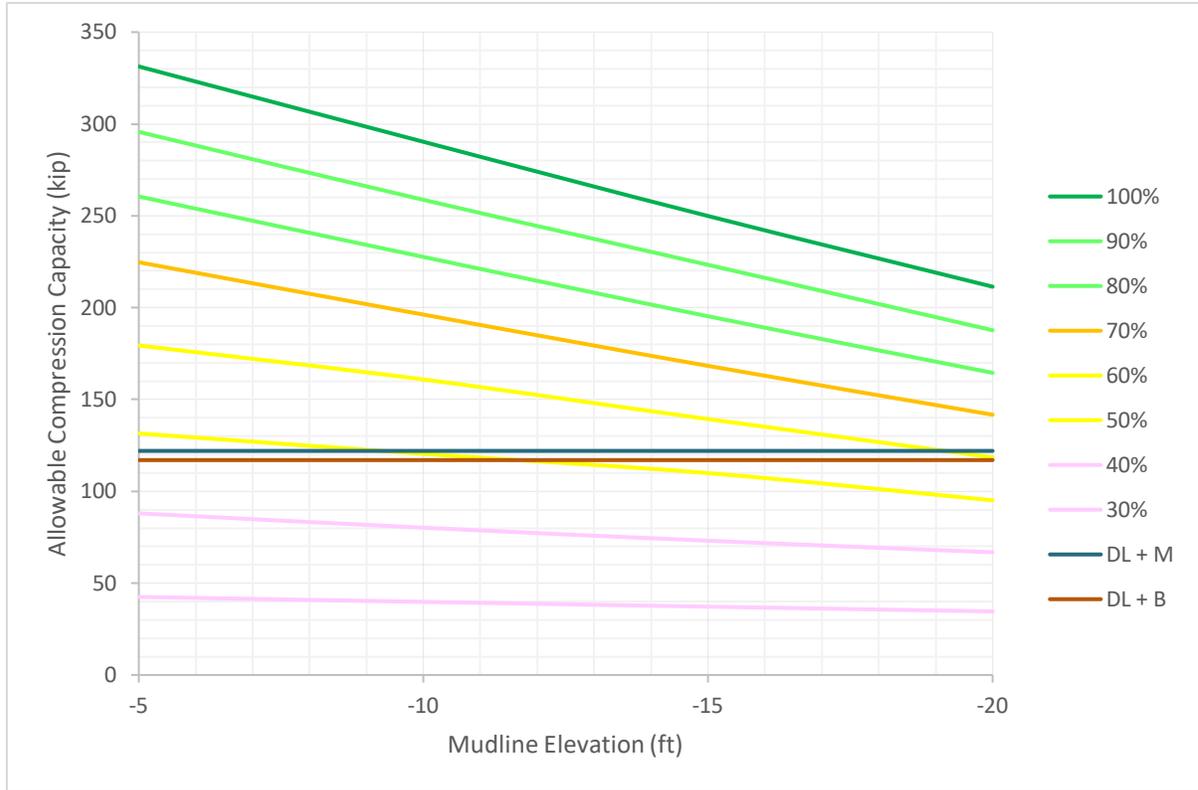
Fig. 12 – Axial Pile Capacity and Berthing/Mooring Loads

the North Pier between Bents P8 and P11, where the most severe deterioration exists. Additionally, a reduced berth velocity is recommended to provide additional factor of safety on applied berthing energy.

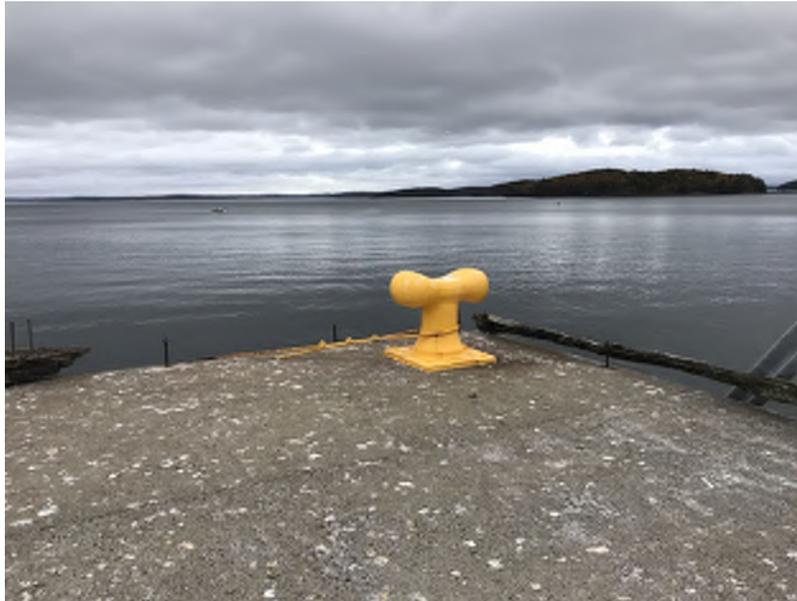
Photo No. 8: Timber curb on northeastern corner of North Pier in poor condition. Bollards are in good condition. Taken by DAP on 10/20/2020 at 4:37PM.

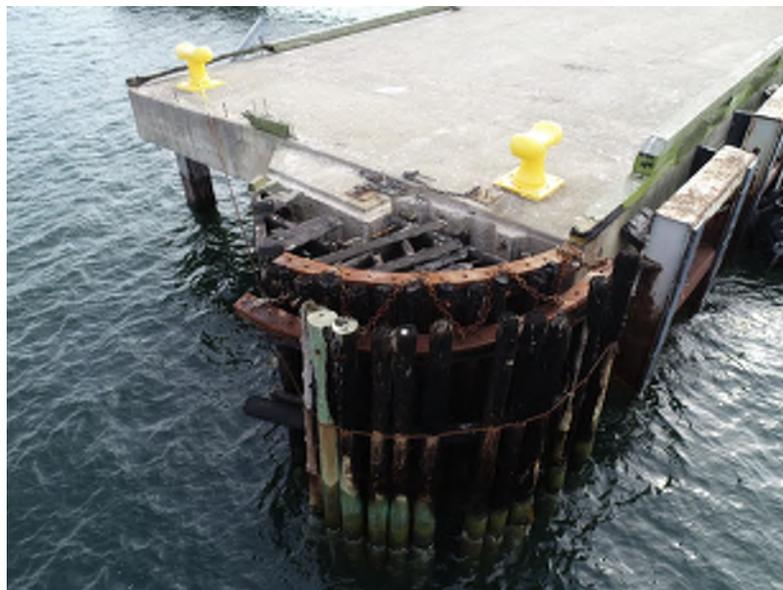
Damage resulting from specific events: For example, damage to the timber breasting piles on the northeast corner of the North Pier related to the fire reported to have occurred on the structure.

Photo No. 9: Burned timber fender piles on eastern end of North Pier. Taken by STH on 10/19/2020 at 2:47PM.

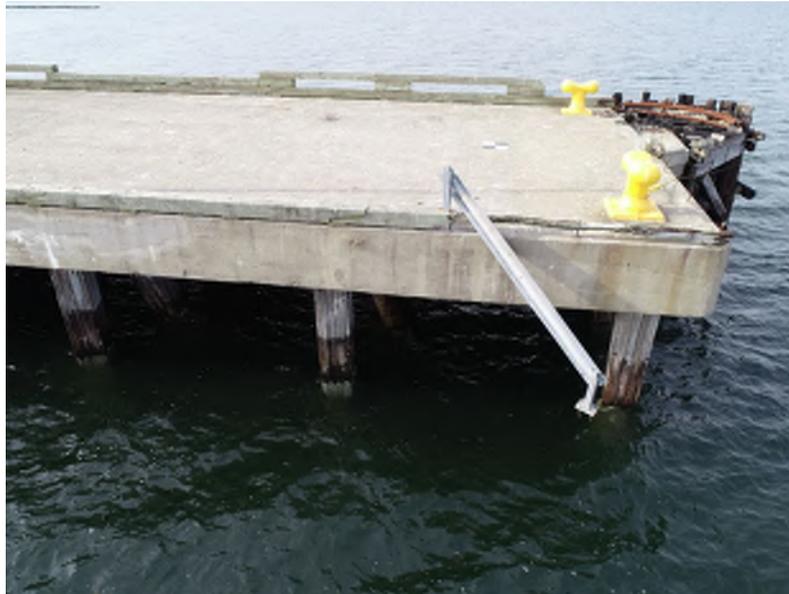
Photo No. 10: Hazardous hanging guardrail near timber curb in poor condition. Taken by STH on 10/19/2020 at 2:48PM.

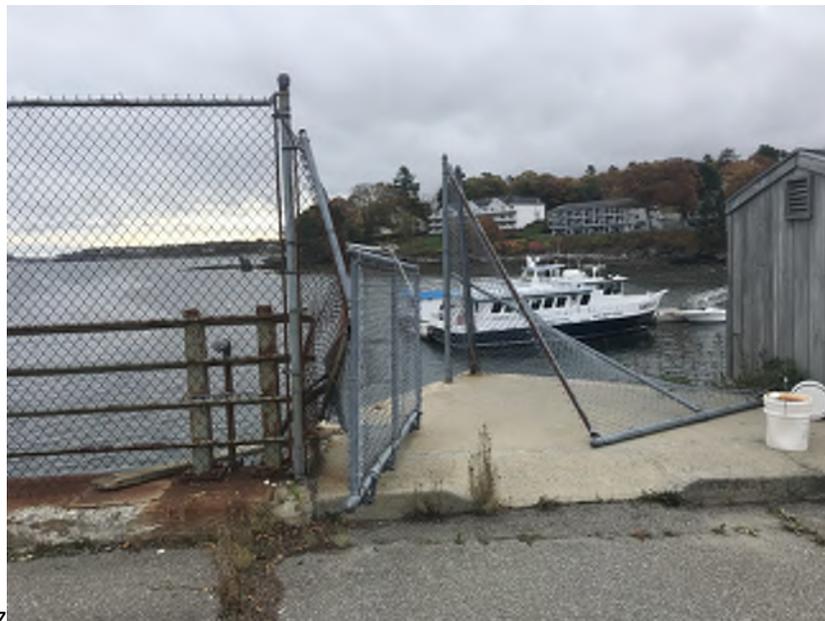
Photo No. 13: Hazardous downed fencing on southern side of revetment. Taken by DAP on 10/23/2020 at 9:19AM.

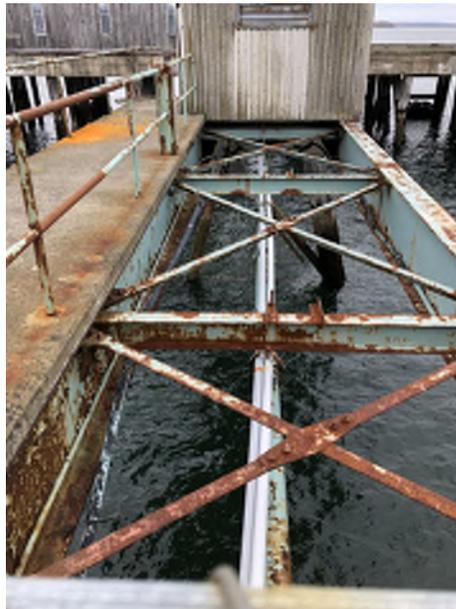
Photo No. 19: Corrosion on Pedestrian Bridge steel support structure. Taken by DAP on 10/23/2020 at 9:13AM.

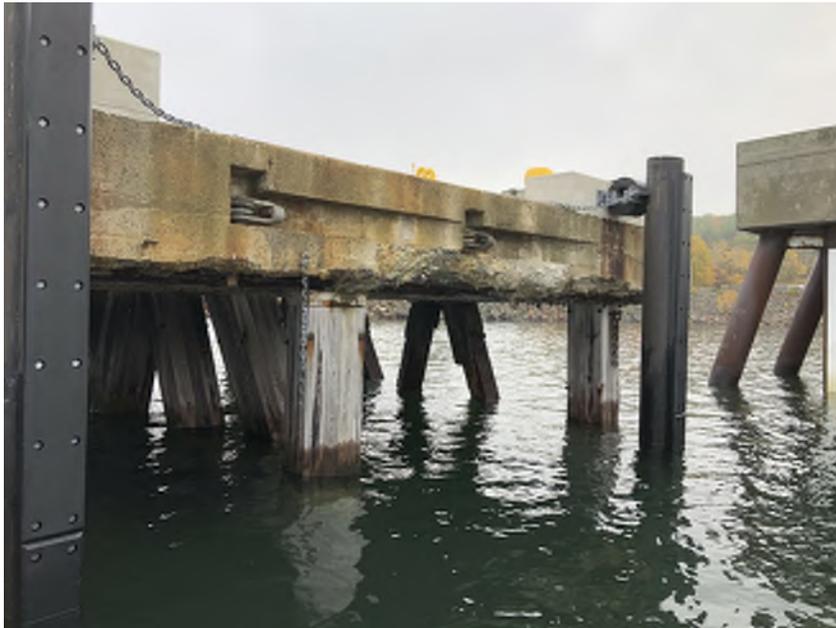
Photo No. 21: Large spall on underside of eastern North Pier. Taken by DAP on 10/21/2020 at 3:48 PM.

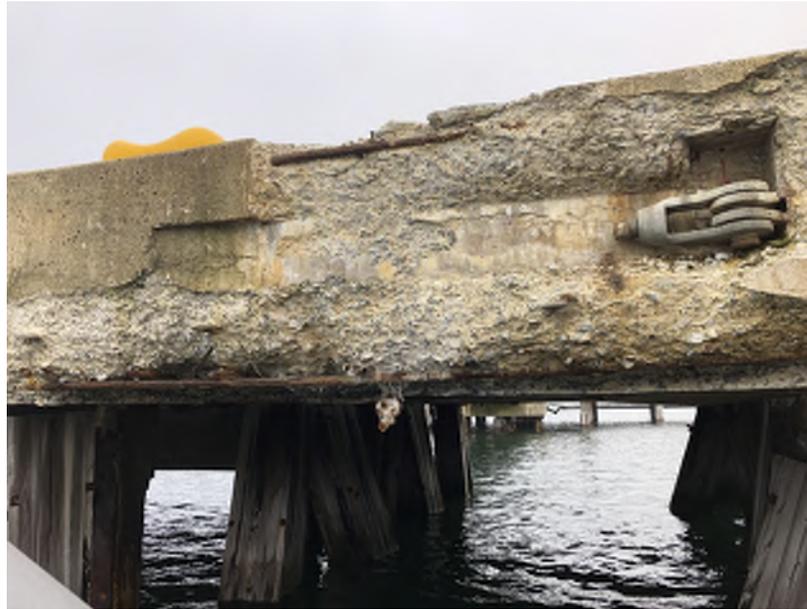
Photo No. 22: Large spall on underside of the North Pier. Taken by DAP on 10/21/2020 at 3:46PM.

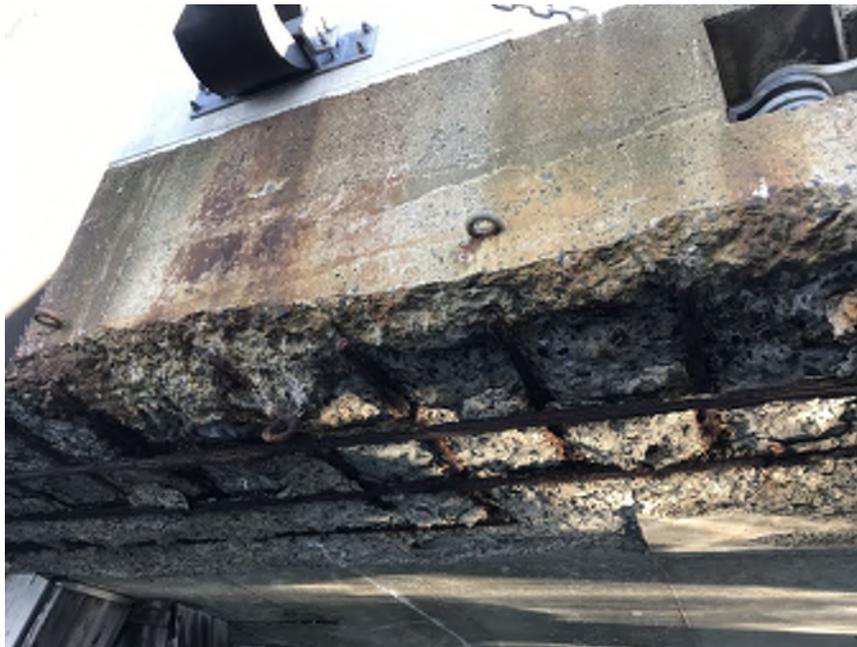
Photo No. 23: Severe spall on underside of North Pier. Taken by DAP on 10/22/2020 at 2:31PM.

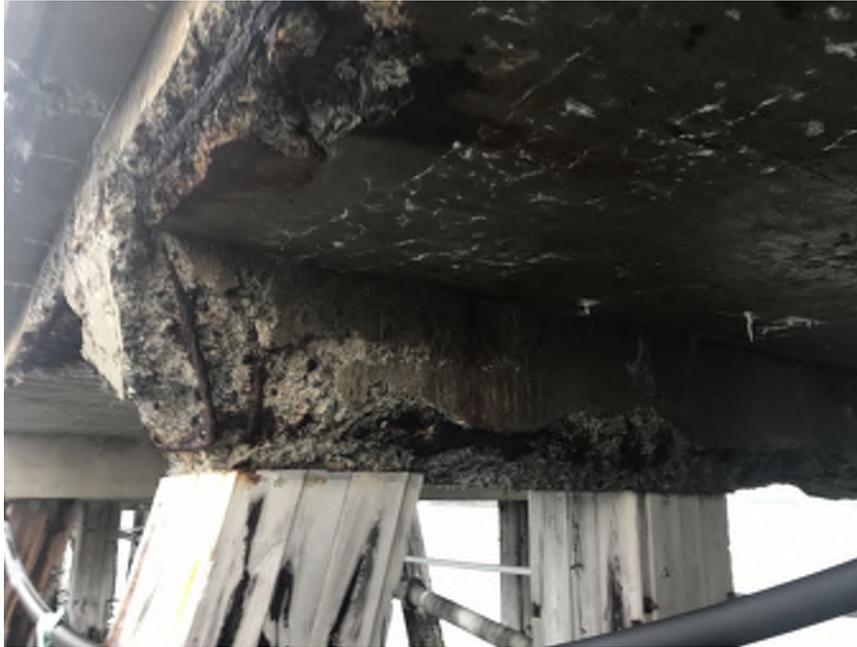
Photo No. 26: Spalling on pile cap along bent 2. Taken by DAP on 10/23/2020 at 9:22AM.

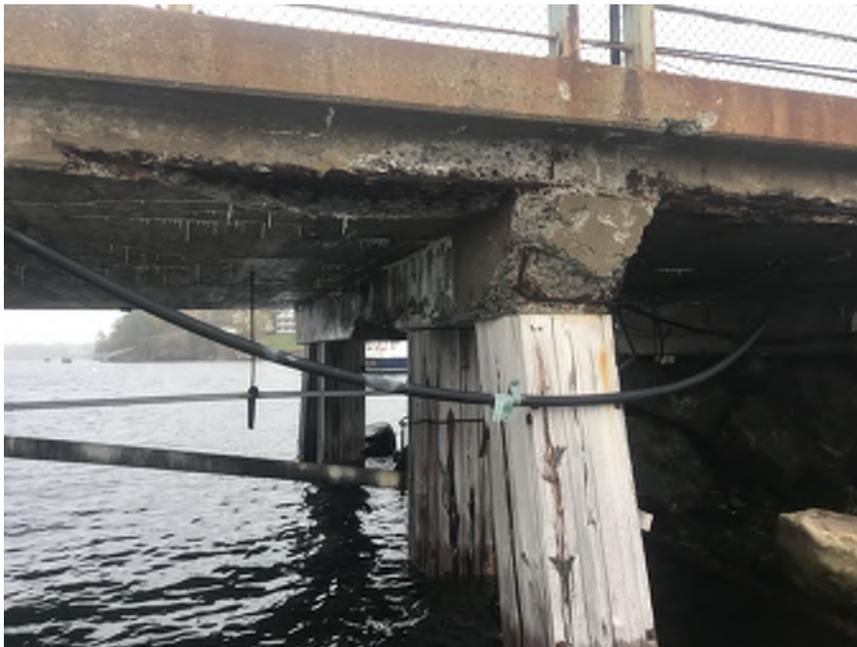
Photo No. 27: Spalling on between bents 1 & 3. Taken by DAP on 10/21/2020 at 3:27PM.

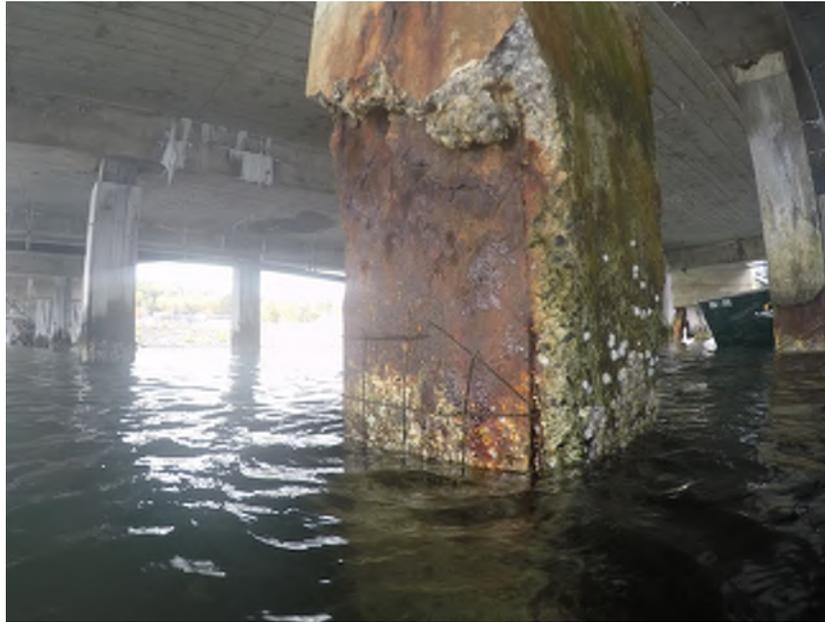
Photo No. 28: Typical concrete corrosion exposing wire mesh. Taken by ASC on 10/21/2020 at 12:09PM.

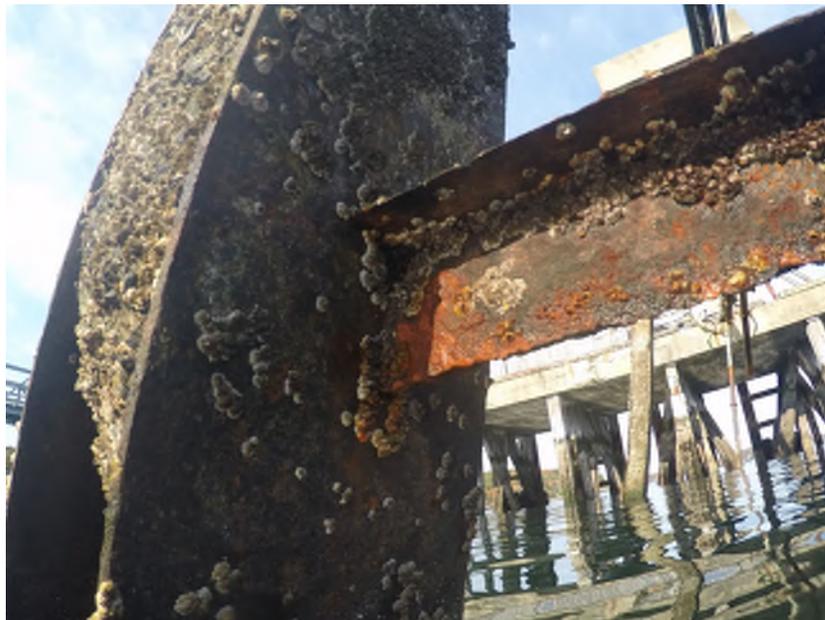
Photo No. 29: Typical knifing on cross-brace structure. Taken by ASC on 10/22/2020 at 10:27PM.

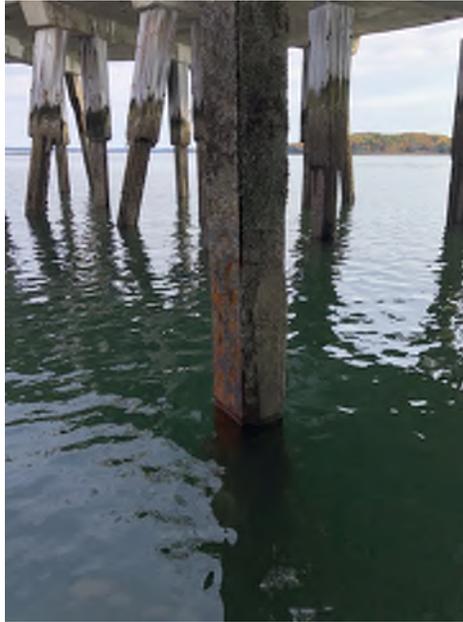
Photo No. 36: Typical pile with concrete corroded from flanges. Taken by ASC on 10/22/2020 at 11:05AM.

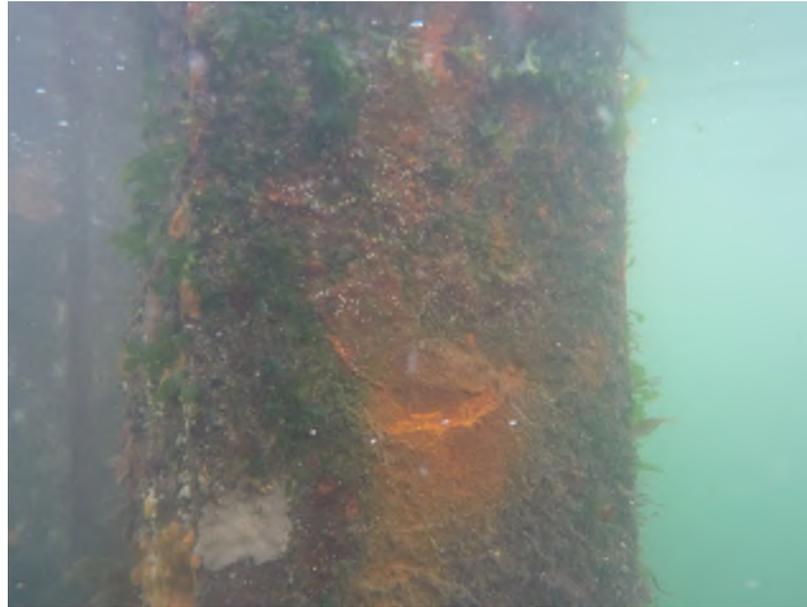
Photo No. 38: Typical corrosion of steel H-piles. Taken by ASC on 10/22/2020 at 1:04PM.

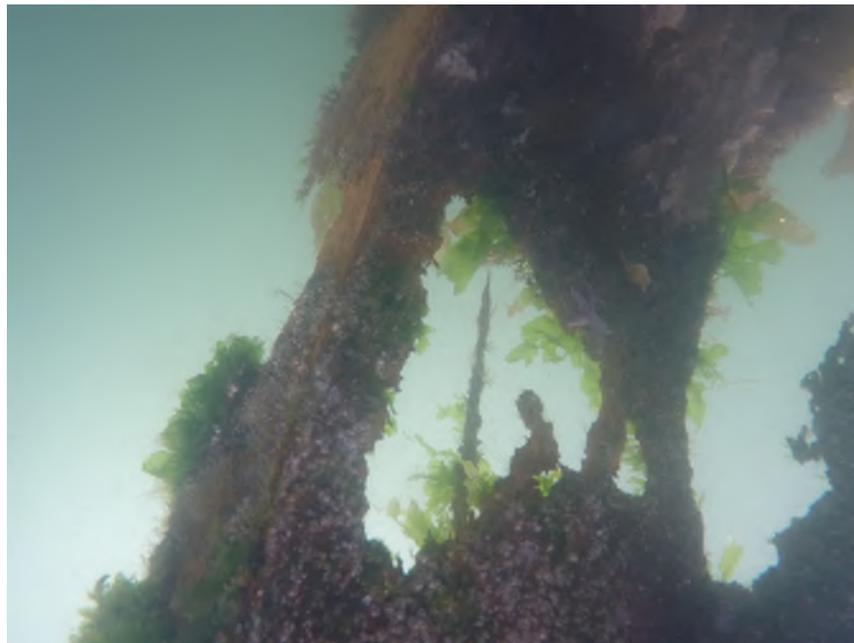
Photo No. 39: Hole in web of pile P14-Fsouth. Taken by ASC on 10/22/2020 at 1:21PM.

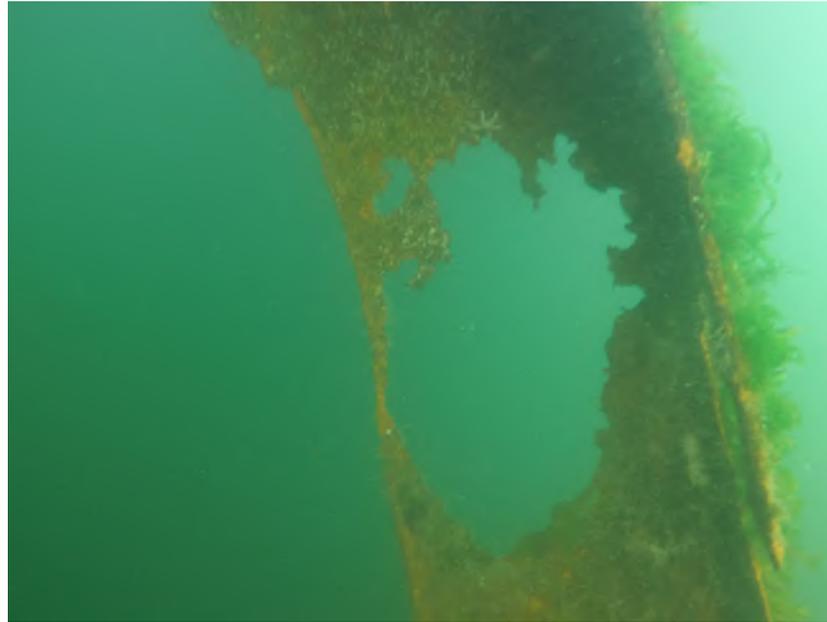
Photo No. 40: Hole in web of pile P14-Fnorth. Taken by ASC on 10/22/2020 at 1:30PM.
