**BAR HARBOR PUBLIC SAFETY BUILDING
FEASIBILITY STUDY**

October 8, 2012

ARCHITECT
Design Group Collaborative
Ellsworth, Maine

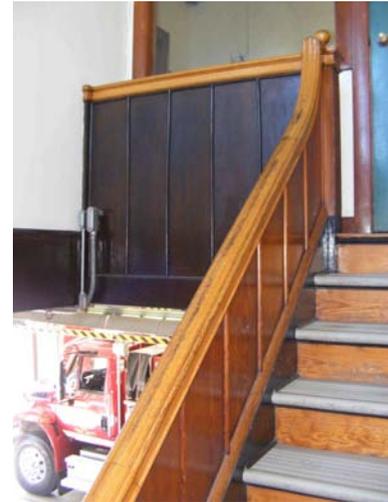
The occupancy for the second floor requires two means of egress. The existing stair leading from the second floor to the level of exit discharge should be protected with a rated stair enclosure. The existing fire escape on the rear of the building currently provides a second means of egress for the meeting room. Extensive renovations could result in the need for an additional code compliant stair.

- *Substantial renovations would create an opportunity to provide proper means of egress and separation of uses. The installation of a supervised sprinkler system in the buildings would benefit future renovations.*
- *The Fire Escape should be inspected and recommended repairs implemented.*

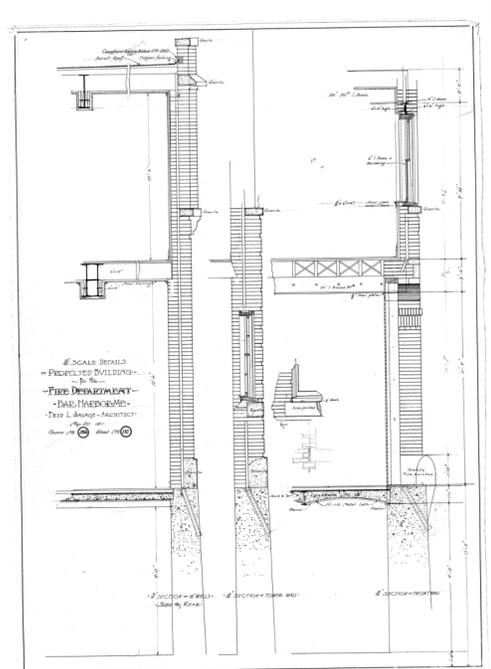
Wall Details, 1910

Rusting was noticed on the underside of some steel window lintels.

-Steel lintels and door frames should be cleaned and repaired and painted.
