Ferry Terminal Inspection and Assessment FINAL REPORT

Bar Harbor, Maine

February 8, 2021
Project 2004148

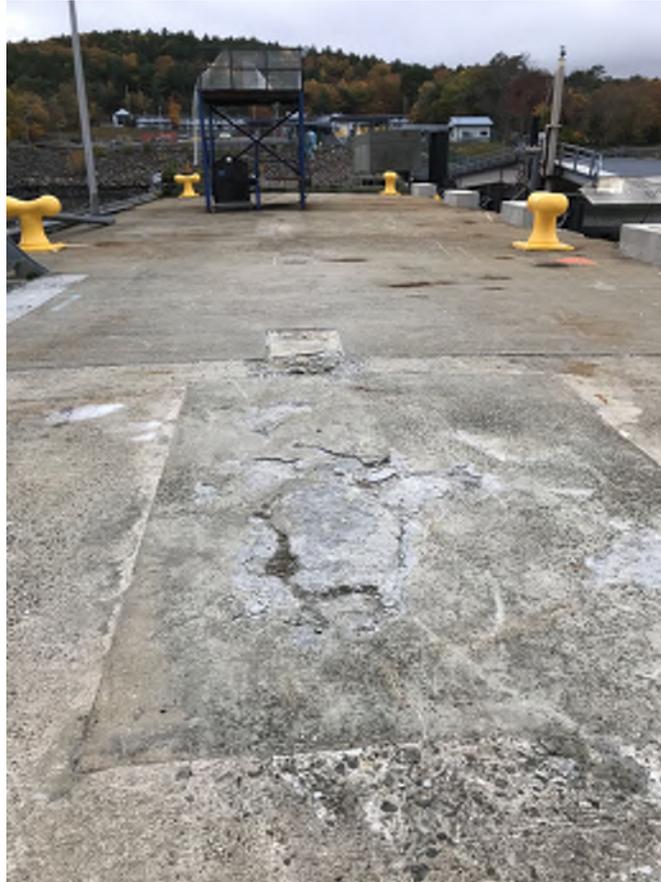
Photo No. 7: Typical topside conditions of North Pier. Taken by DAP on 10/20/2020 at 4:36PM.

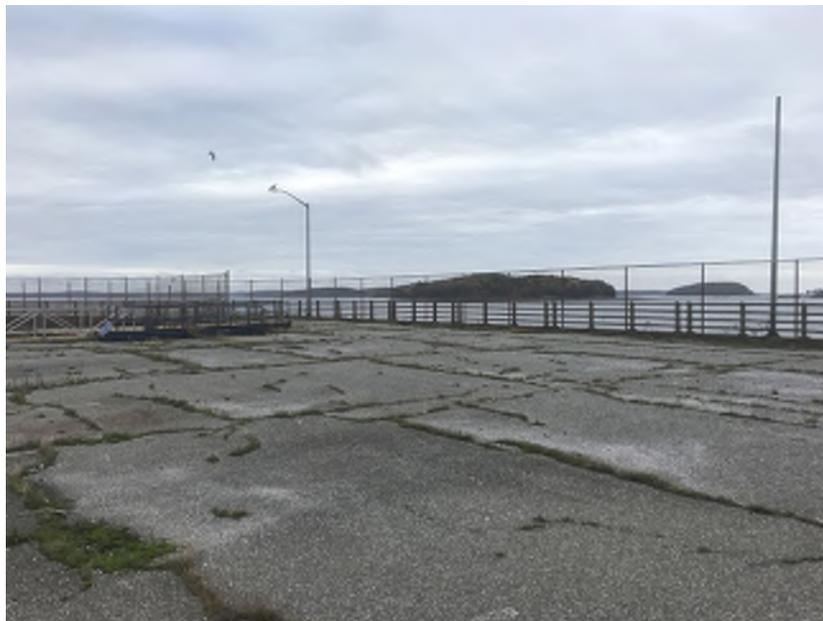
Photo No. 11: Typical condition of South Pier asphalt. Taken by DAP on 10/20/2020 at 4:26PM.

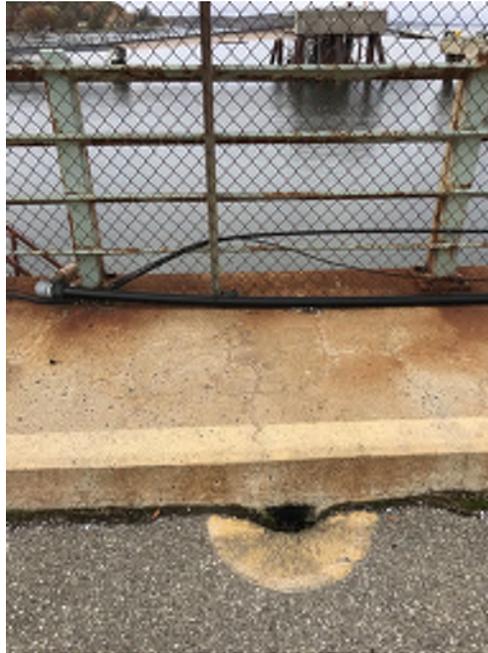
Photo No. 12 Typical sunken drain on South Pier. Taken by DAP on 10/24/2020 at 4:19PM.

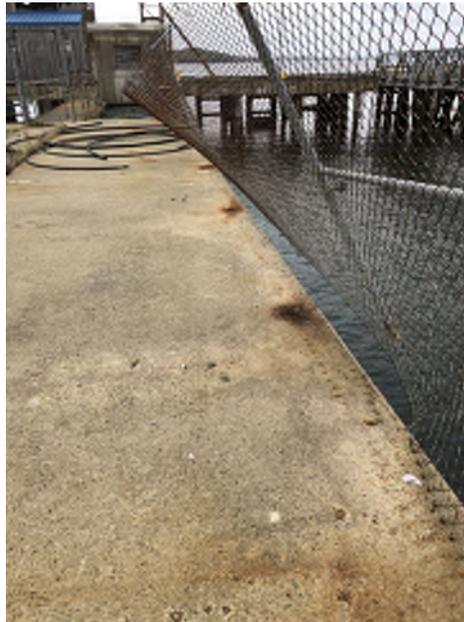
Photo No. 14: Downed fencing on South Pier. Taken by DAP on 10/23/2020 at 9:12AM.

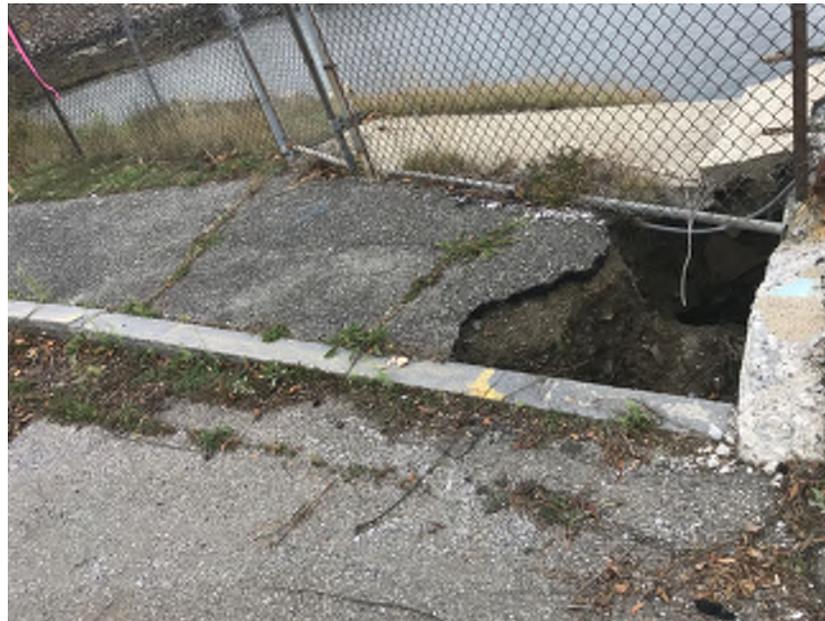
Photo No. 15: Hole in asphalt on northern side of revetment. Taken by DAP on 10/23/2020 at 9:18AM.

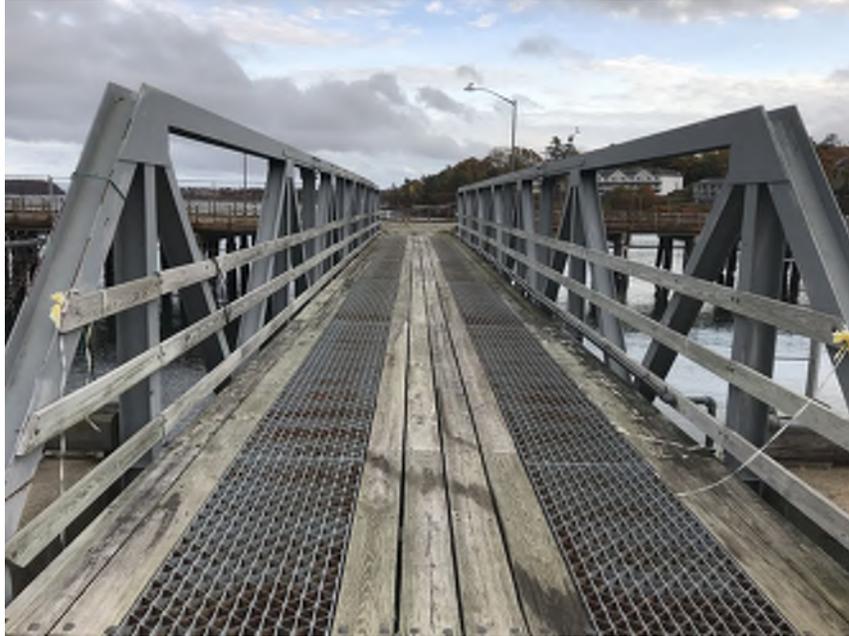
Photo No. 16: Topside conditions of West Vehicle Bridge. Taken by DAP on 10/23/2020 at 9:13AM.

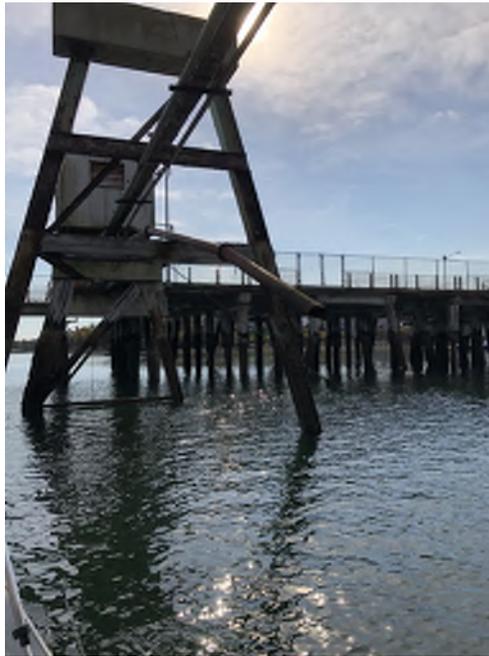
Photo No. 18: Steel pipe hanging from Pedestrian Bridge. Taken by DAP on 10/22/2020 at 11:12AM.

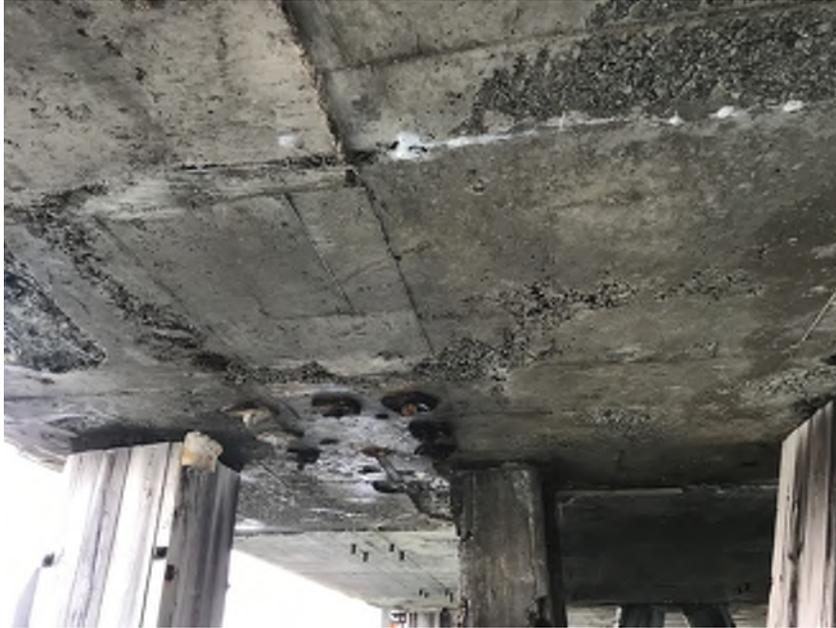
Photo No. 20: Typical North Pier underside conditions. Taken by DAP on 10/22/2020 at 2:17PM.

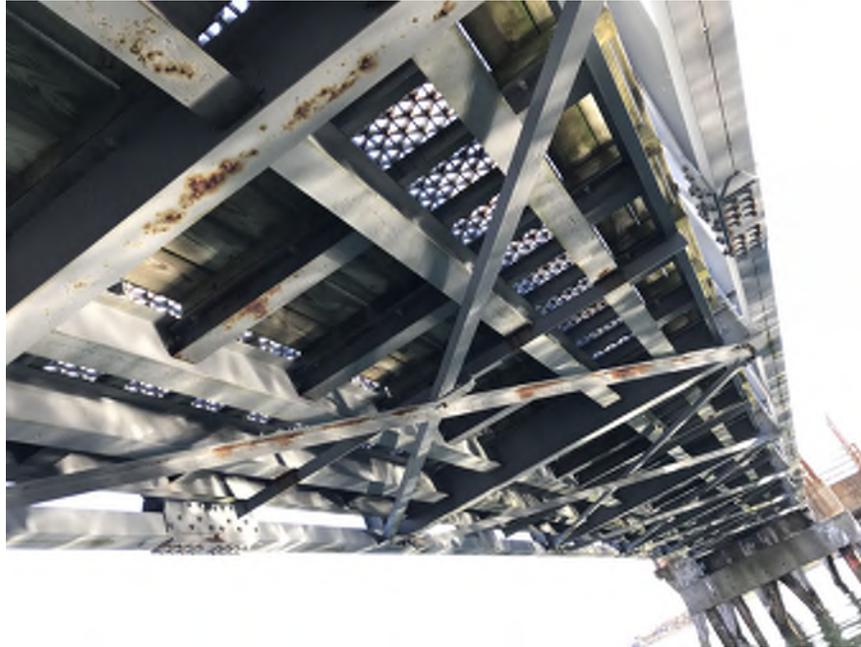
Photo No. 24: Typical Vehicle Ramp underside conditions. Taken by DAP on 10/22/2020 at 2:36PM.

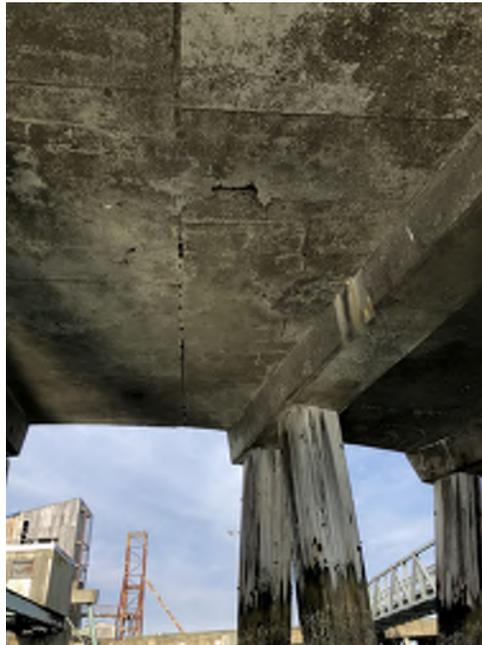
Photo No. 25: Typical South Pier underside conditions. Taken by DAP on 10/22/2020 at 11:02AM.

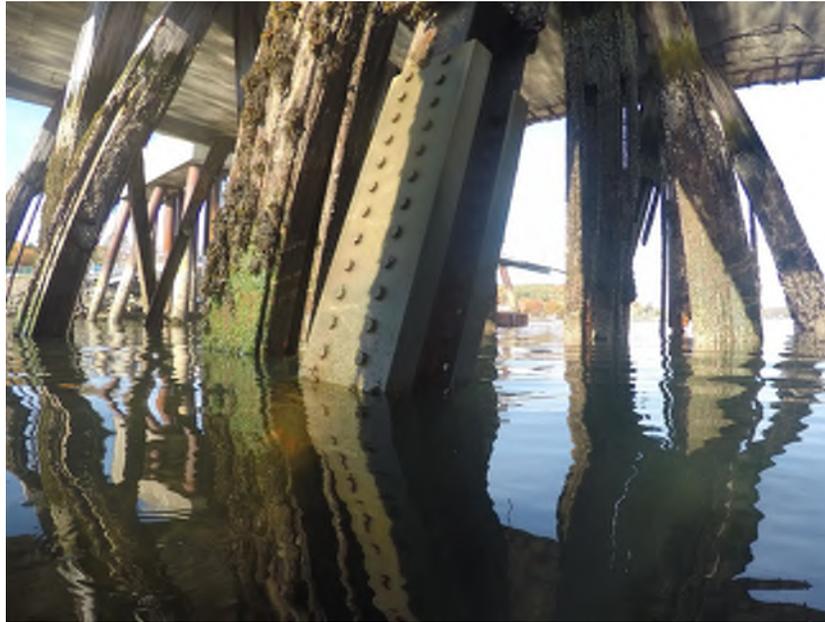
Photo No. 30: Typical condition of pile repairs. Taken by ASC on 10/22/2020 at 9:34AM.

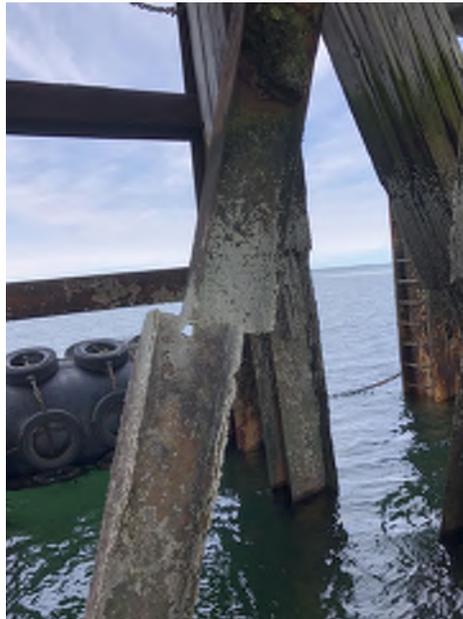
Photo No. 31: Typical condition of pile repairs. Taken by ASC on 10/22/2020 at 9:34AM.

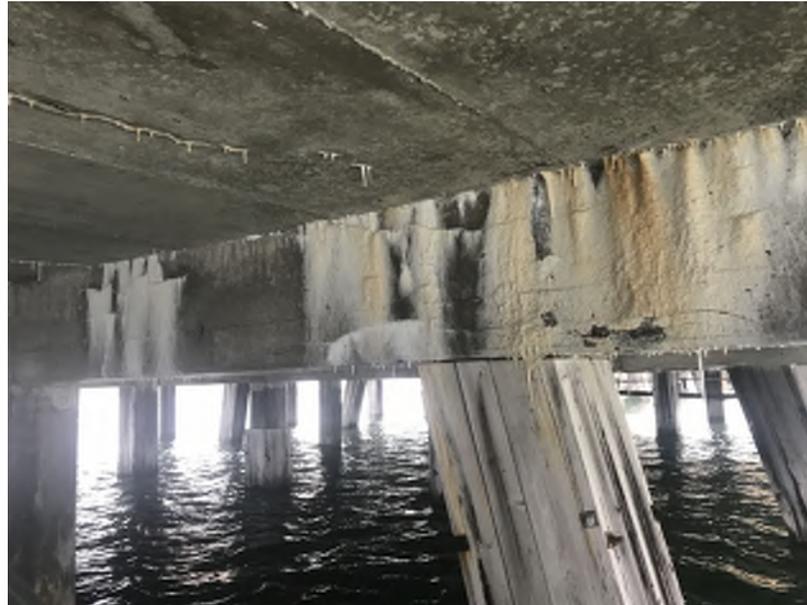
Photo No. 32: Severe efflorescence on underside of South Pier. Taken by DAP on 10/21/2020 at 3:11PM.

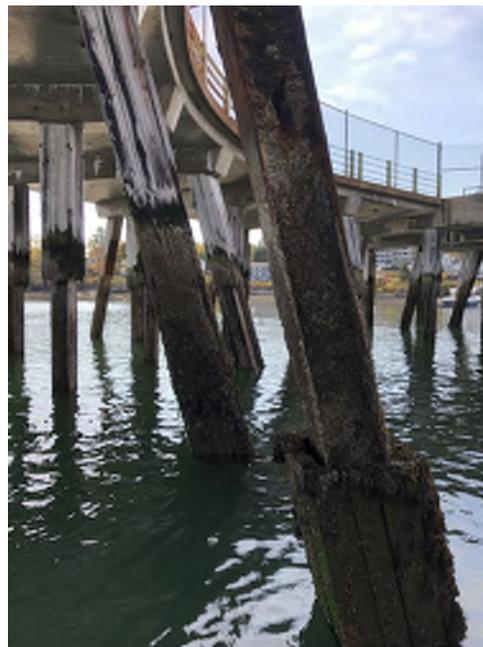
Photo No. 33: Typical sliding of timber jacketing. Taken by DAP on 10/22/2020 at 11:07PM.
